UNITED STATES ENVIRONMENTAL PROTECTION AGENCY
REGION III
1650 Arch Street
Philadelphia, Pennsylvania 19103-2029

Re: Request for Information Pursuant to Section 3007(a) of the Resource Conservation and Recovery Act, 42 U.S.C. § 6927(a), Regarding Generation and Management of Hazardous Waste by Akzo Nobel Coatings Inc.
EPA ID No. VAD000019828
Reference No. C06-003

Comprehensive Compliance Monitoring and Enforcement Report

AKZO Nobel
Roanoke, VA
VAD000019828

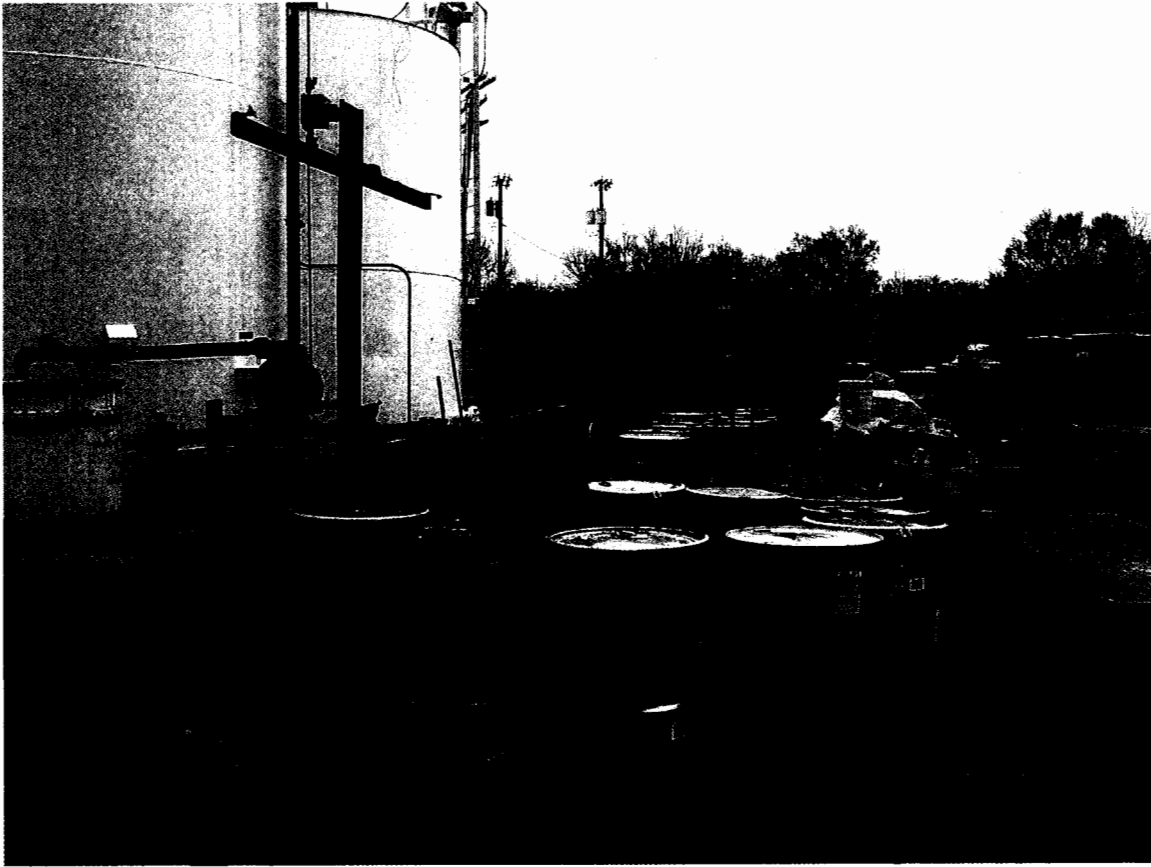
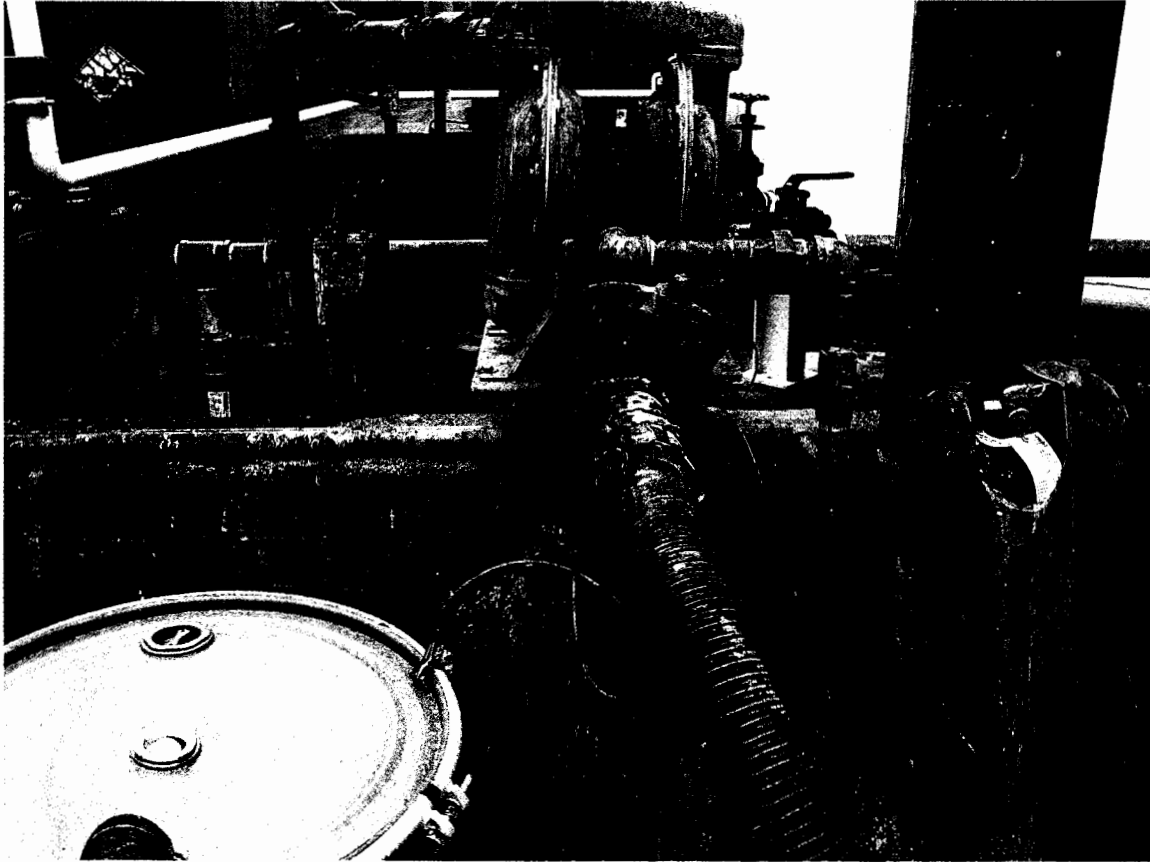
- b. Please provide a narrative to accompany the flow diagram that explains the movement of all hazardous wastes in detail.
2. The inspection report describes a tank, identified as the Hazardous Waste Storage Tank, which apparently accumulates hazardous wastes from throughout the facility and is the location from which bulk shipments of hazardous waste are processed. (see Photographs 42, 47, 48 & 49)

Main Less Than 90-Day Storage Area
Hazardous Waste Storage Tank is on the left

Hazardous Waste Storage Tank Area
Pump , hose and piping thru which Hazardous Waste is pumped into the Tank

Hazardous Waste Storage Tank
Piping used to pump in and out of the Tank
The tank itself is in the forefront

Hazardous Waste Storage Tank

- a. Please describe the specific contents of the waste stream collected in the Main Hazardous Waste Storage Tank, indicating if it is a hazardous waste and identifying all applicable hazardous waste codes.

- b. Please describe in detail any containers used to store the material that is withdrawn from the Main Hazardous Waste Storage Tank.
 - c. Provide a detailed list of all equipment, as defined in 40 C.F.R. § 264.1031, associated with the Main Hazardous Waste Storage Tank.

- d. Provide information/documentation demonstrating that the Main Hazardous Waste Storage Tank and its associated equipment is or is **not** exempt from air emission standards for equipment leaks as specified in 40 C.F.R. § 265.1050.

- f. If the facility has determined the facility **is not** exempt, please provide documentation, as of April 12, 2005, to support that the ancillary equipment associated with this waste stream **was** fulfilling the requirements of the air emission standards for equipment leaks as specified in 40 C.F.R. § 265.1050.

- g. Please describe in detail any and all measures the facility has instituted since April 12, 2005, to document that the ancillary equipment associated with this waste stream **is** fulfilling the requirements of the air emission standards for equipment leaks as specified in 40 C.F.R. § 265.1050.

- h. Please provide the date when the storage of hazardous waste in the Hazardous Waste Storage Tank first commenced.
 - i. Please provide the documentation, as defined in 40 C.F.R. § 265.195, of the inspections of the Hazardous Waste Storage Tank and associated equipment for the **past three (3) years**.

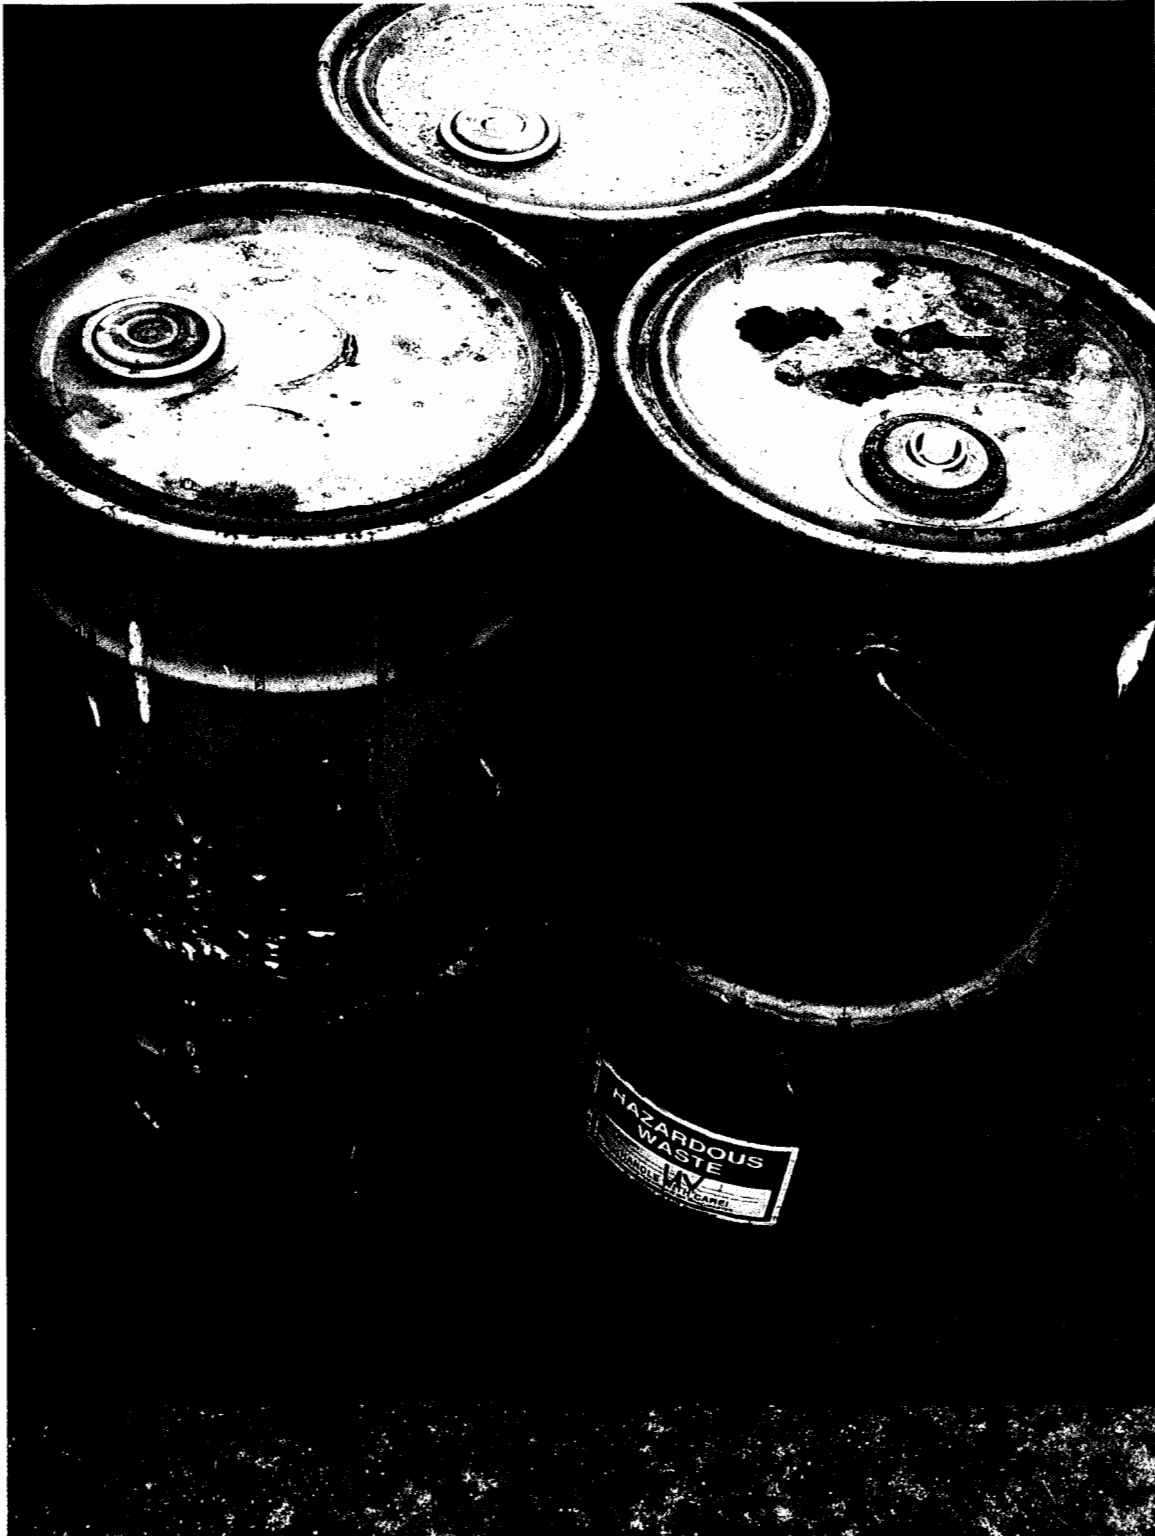
PHOTO 43

3. While inspecting the Main <90-Day Hazardous Waste Storage Area, the inspector observed the following:
- a. Four (4) 5-Gal containers (See Photograph 43) One of these containers was observed to have a hazardous label, none of these containers was observed to be marked with an accumulation start date.

Main Less Than 90-Day Storage Area
Four 5 gal containers, three are unlabeled
Fourth, on bottom right, labeled "Hazardous Waste" but not dated

- i. Please provide a detailed description of the process or processes which generated the materials in each of these containers.
- ii. Describe the contents of each of these containers observed during EPA's April 2005 CEI, and provide the basis for your knowledge of such contents.

- v. Were the materials in any of these containers determined to be "hazardous waste?" If so, please state the specific EPA Hazardous Waste Code(s) associated with each such hazardous waste in each of these containers.

- vi. State in each case whether the hazardous waste determination was based on the generator's knowledge of the process that generated the waste, or on analytic results. If the determination was based on analytical results, provide any and all such results.

- vii. Were any of these containers shipped off-site for recycle (i.e., reclaim, re-use), treatment, storage or disposal?
- viii. If any of these containers were shipped off-site, provide copies of **all** bills of lading, manifests (including hazardous waste manifests), shipping invoices, and LDR notices and certifications that accompanied the off-site shipment of any said container.

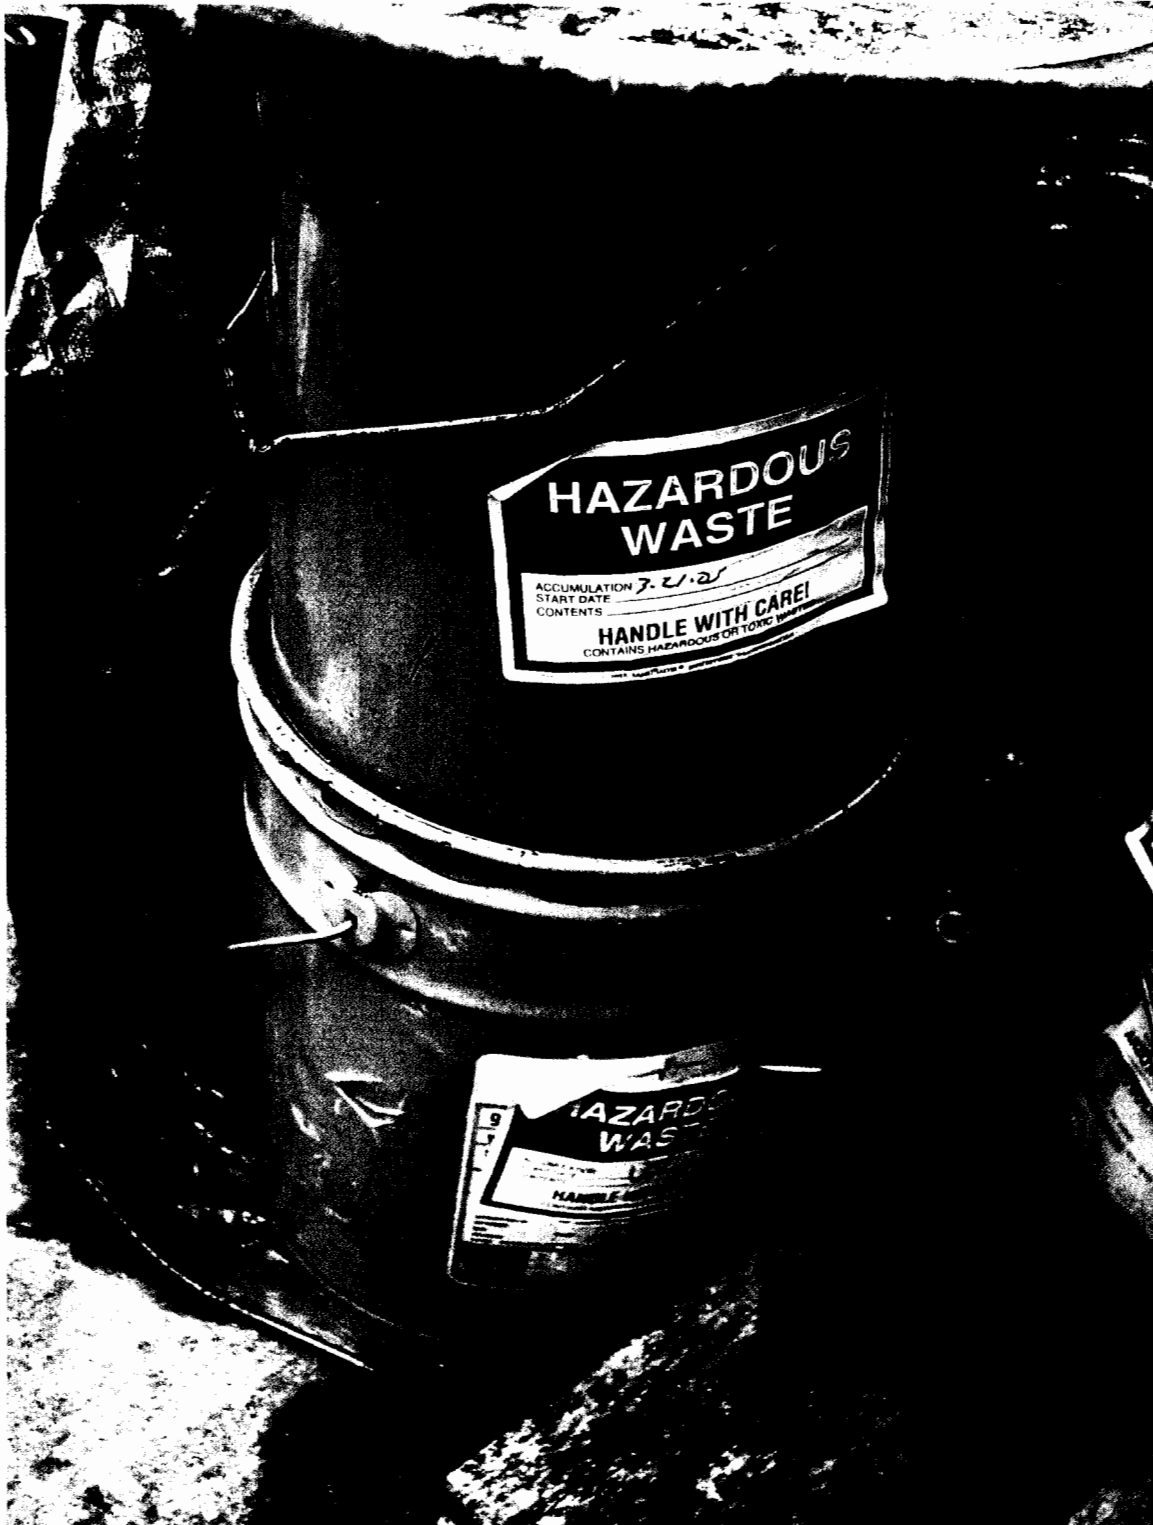
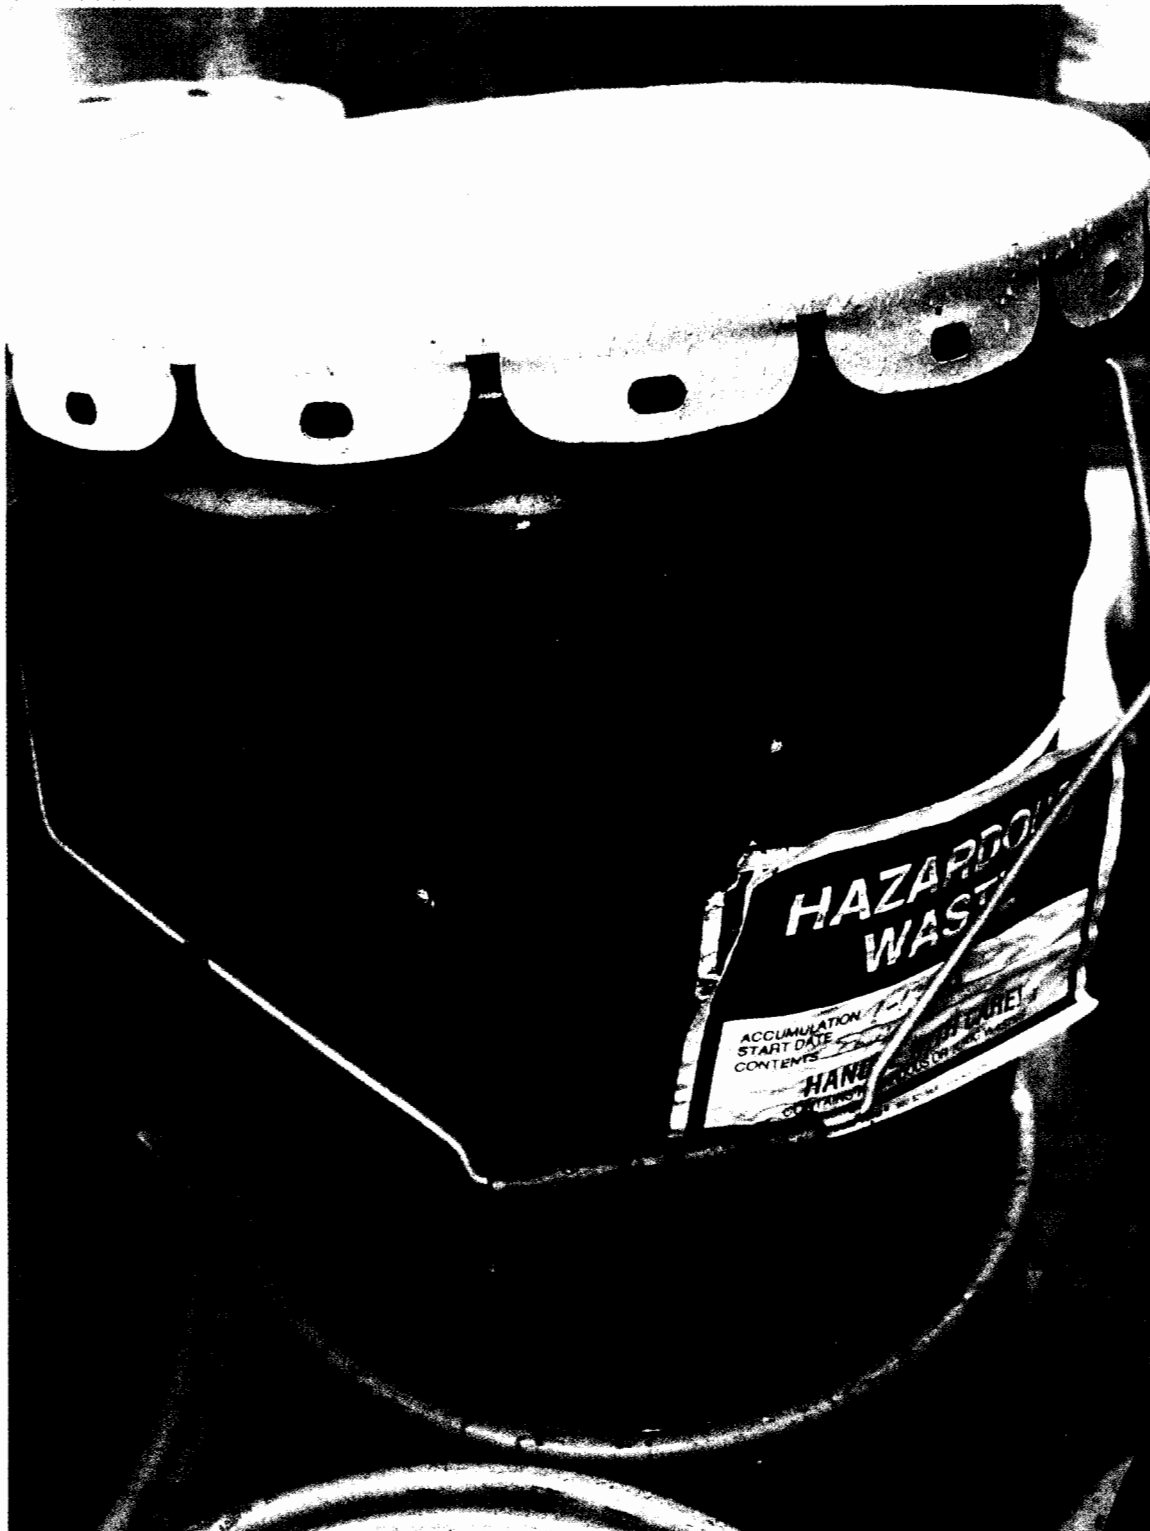
PHOTO 44

- b. Three (3) 5-Gal containers (See Photographs 44 & 45) These three containers were all observed to be labeled as hazardous waste and marked with accumulation start dates. None of these three containers was observed to be "closed".

Main Less Than 90-Day Storage Area - Two 5 gal containers labeled as "Hazardous Waste". A lid for a 55 gal drum laying on top of the upper bucket is the only covering Bottom container is not dated

Main Less Than 90-Day Storage Area
5 gal container labeled "Hazardous Waste" and "Thinner" dated 1/13/05
Lid is loose and leaves gaps

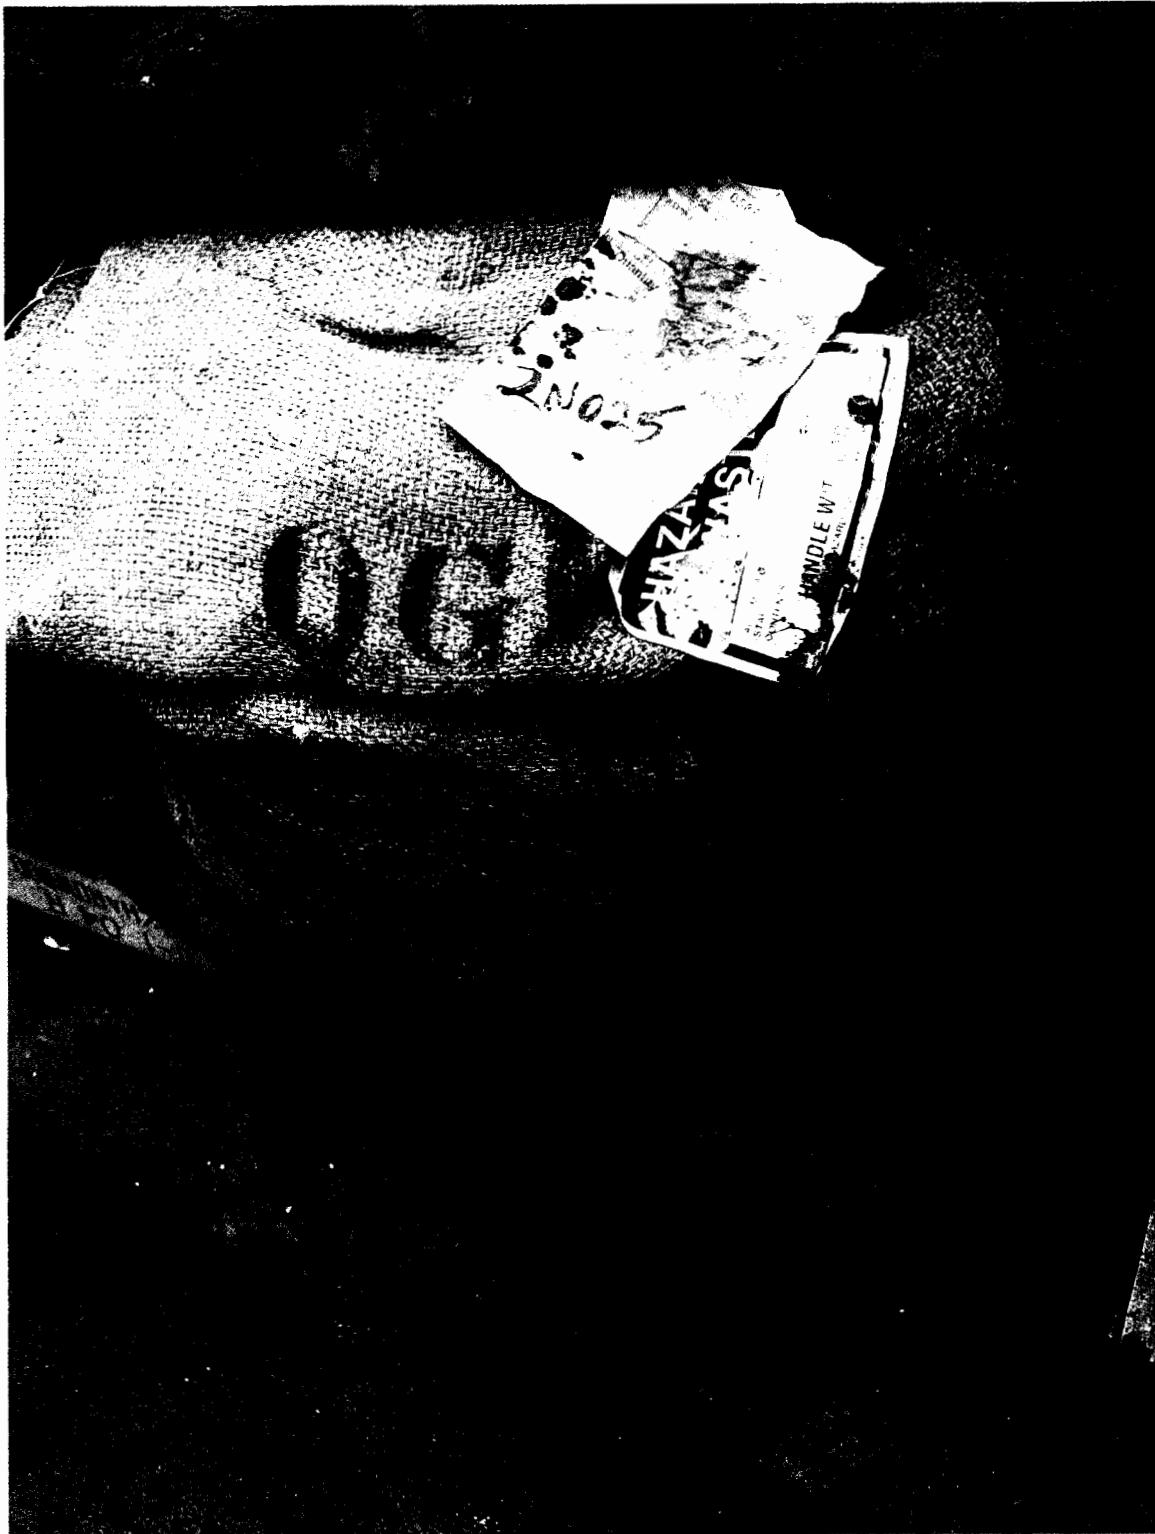
PHOTO 46

- c. One burlap bag (See Photograph 46) This bag was observed to be labeled with a hazardous waste label. No accumulation start date was observed. With regard to each of these containers:

Main Less Than 90-Day Storage Area
Burlap bag labeled "Hazardous Waste" and "2N025"
Dated 3/17/05

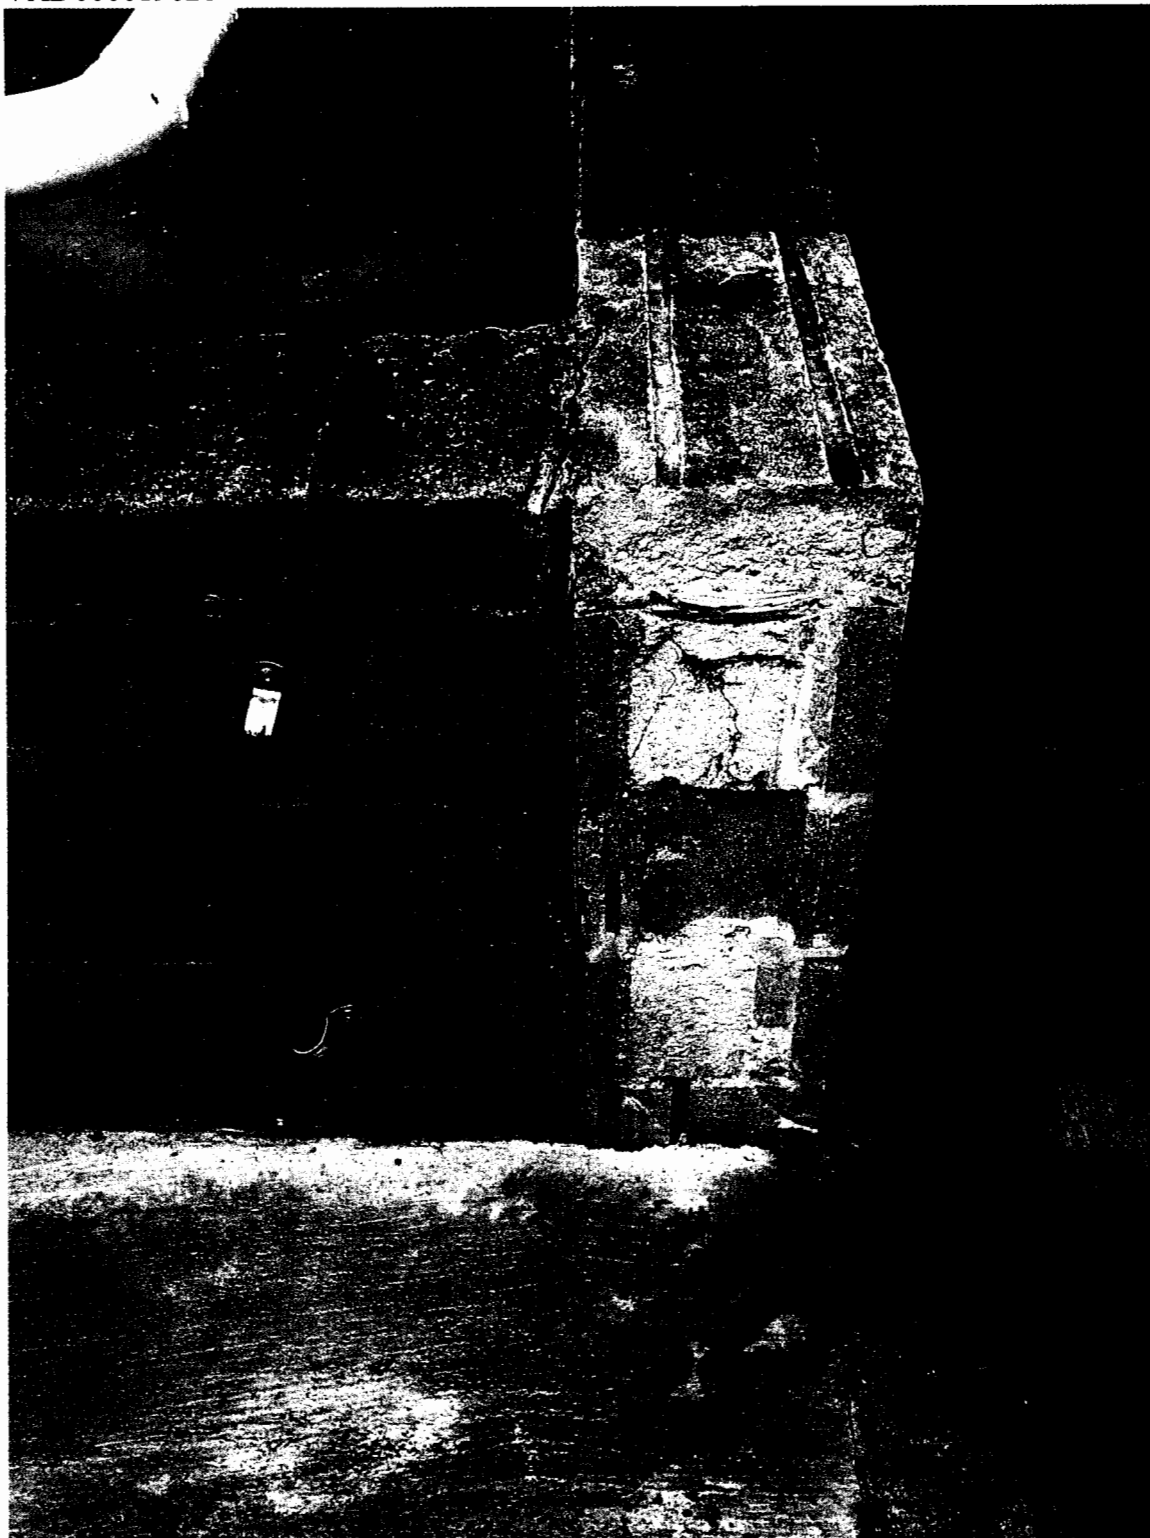
- j. During EPA's April 12, 2005 CEI the inspector observed a damaged area of the secondary containment wall surrounding the Hazardous Waste Storage Tank. (See Photographs 50 & 51) With regard to this damaged area, please answer the following:

Hazardous Waste Storage Tank Secondary Containment
Front left corner of the secondary containment
Crack in containment goes from top to bottom

Hazardous Storage Tank Secondary Containment
Same crack as shown in PHOTO 50 but from the inside of the containment
Shows the crack is through the entire thickness of the wall

- i. For this damaged area, please refer to the attached photos and provide a detailed description of how the damage occurred.
 - ii. Please state the exact date on which this damage occurred and how the facility became aware of it.

- iii. For both questions i and ii above, provide documentation supporting your response to each of these questions.
 - iv. Has the damaged area of the secondary containment wall been repaired? If so, please provide a detailed description of how the secondary containment wall was repaired, the date such repair occurred and photographs of the repaired secondary containment wall.

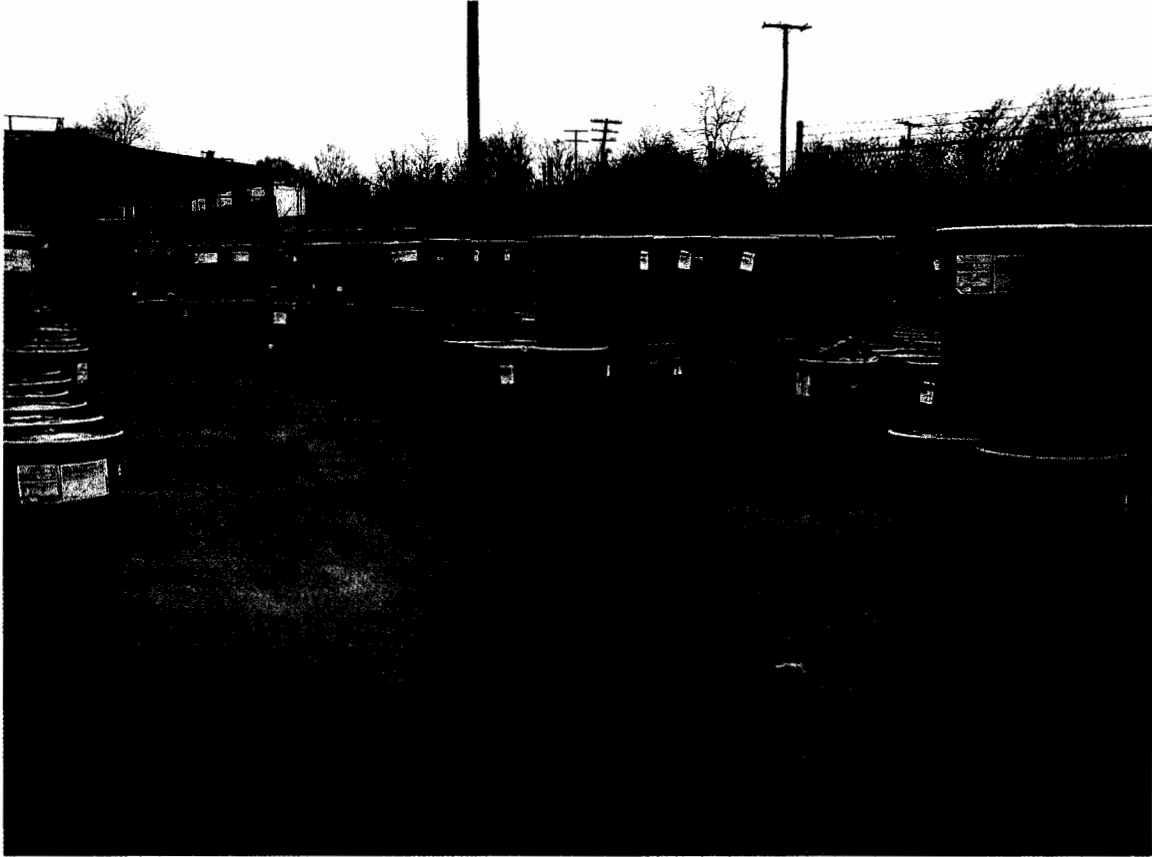
PHOTO 52

The large work-off area is where out of spec product and old raw materials are stored. (PHOTOS 52 & 53) Materials are stored here until determination is made by the Waste Minimization Manager, Steve Ocer, on whether the materials can be used. Mr. Ocer maintains a monthly report, "75% Rule Monthly Report" (Attachment 6) to ensure that at least 75% of this material is used annually.

Work-Off Storage Area

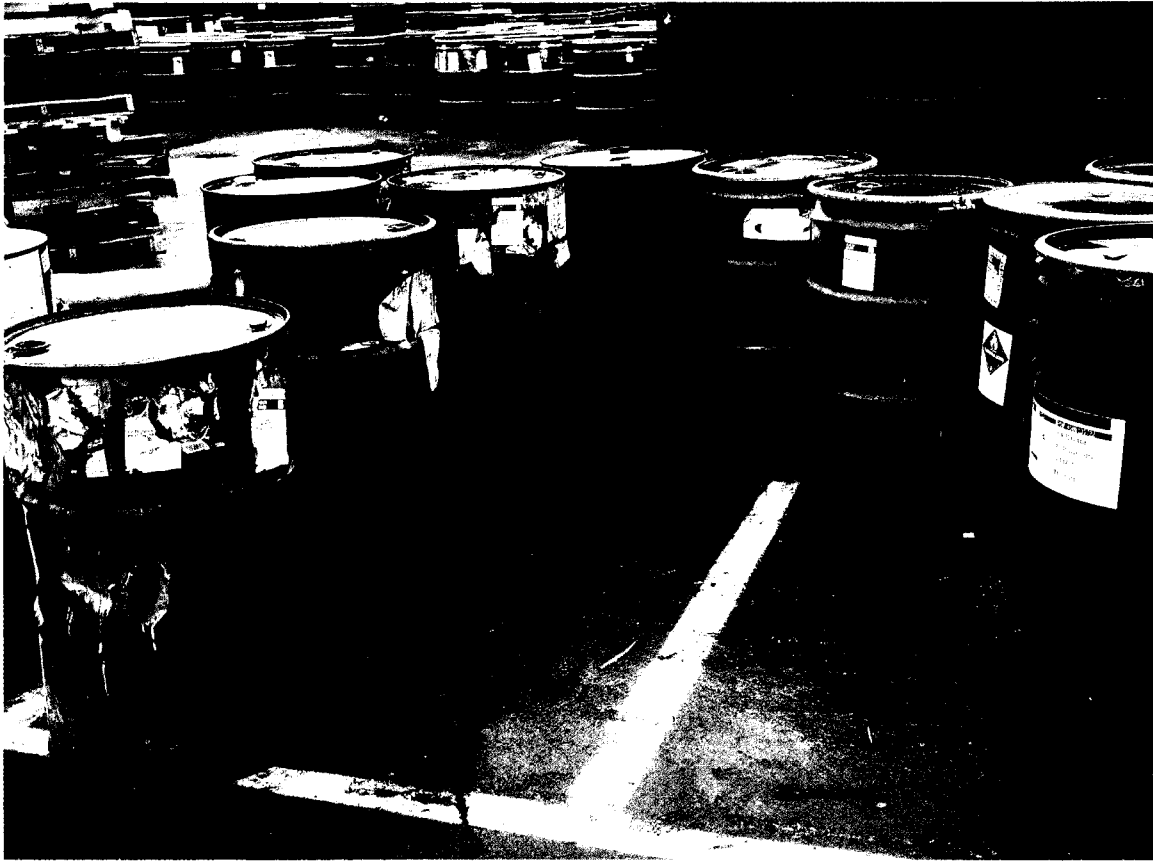
PHOTO 53

Work-Off Storage Area
Older looking raw material drums, questionable container integrity

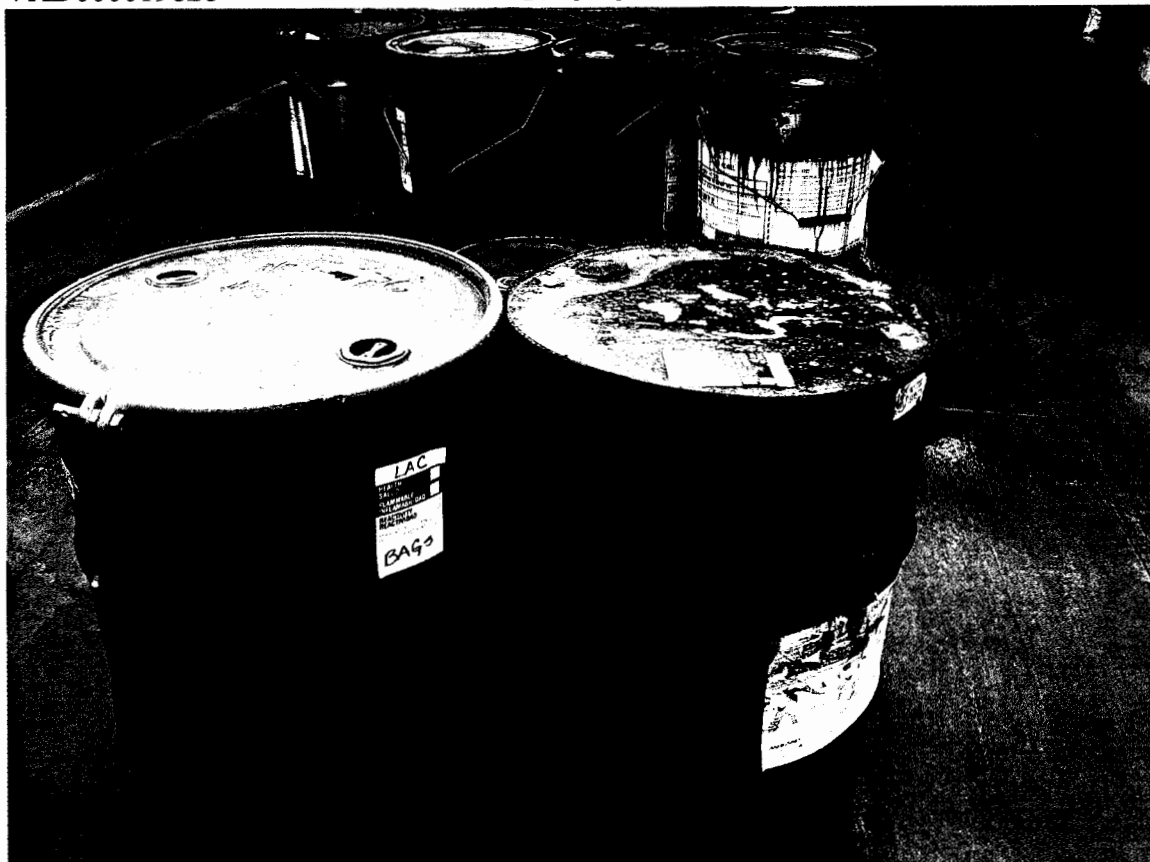
PHOTO 54

Work-Off Storage Area #2 (By Main Less Than 90-Day Storage Area)

55 gal container labeled "LAC BAGS"

4. While inspecting the Product Work-Off Area, the inspector observed a pallet (See Photograph 55) of 35 (5-gal containers) The facility representative stated they were not workoffs but was unsure of their contents and their destination. Additionally, a steel container was observed that was labeled "LAC BAGS". (See Photograph 54) The facility representative stated that this container should be labeled as hazardous waste and moved to the <90-Day Hazardous Waste Storage Area. With regard to each of these containers:

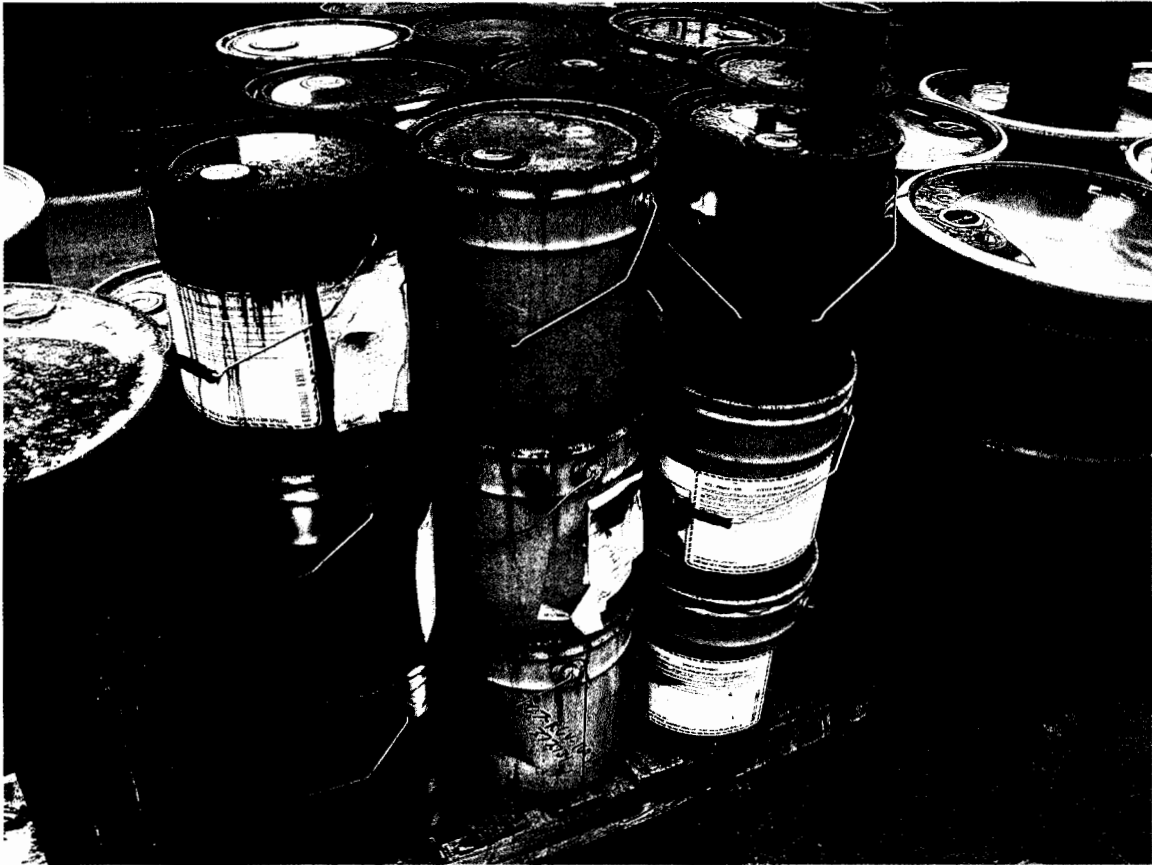
PHOTO 55

Work-Off Area #2 (By Main Less Than 90-Day Storage Area)

Collection of approx. 35 five gal containers

- a. Please provide a detailed description of the process or processes which generated the materials in each of these containers.
- b. Describe the contents of each of these containers observed during EPA's April 2005 CEI, and provide the basis for your knowledge of such contents.
- c. State whether a "waste determination" and "LDR determination" was made for the contents of each of these containers.
- d. If a "waste determination" and "LDR determination" were made for the contents of each of these containers, state when each such determination was made.
- e. Were the materials in any of these containers determined to be "hazardous

waste?" If so, please state the specific EPA Hazardous Waste Code(s) associated with each such hazardous waste in each of these containers.

- f. State in each case whether the hazardous waste determination was based on the generator's knowledge of the process that generated the waste, or on analytical results. If the determination was based on analytical results, provide any and all such results.
- g. Were any of these containers shipped off-site for recycle (i.e., reclaim, re-use), treatment, storage or disposal?
- h. If any of these containers were shipped off-site, provide copies of all bills of lading, manifests (including hazardous waste manifests), shipping invoices, and LDR notices and certifications that accompanied the off-site shipment of any said container.

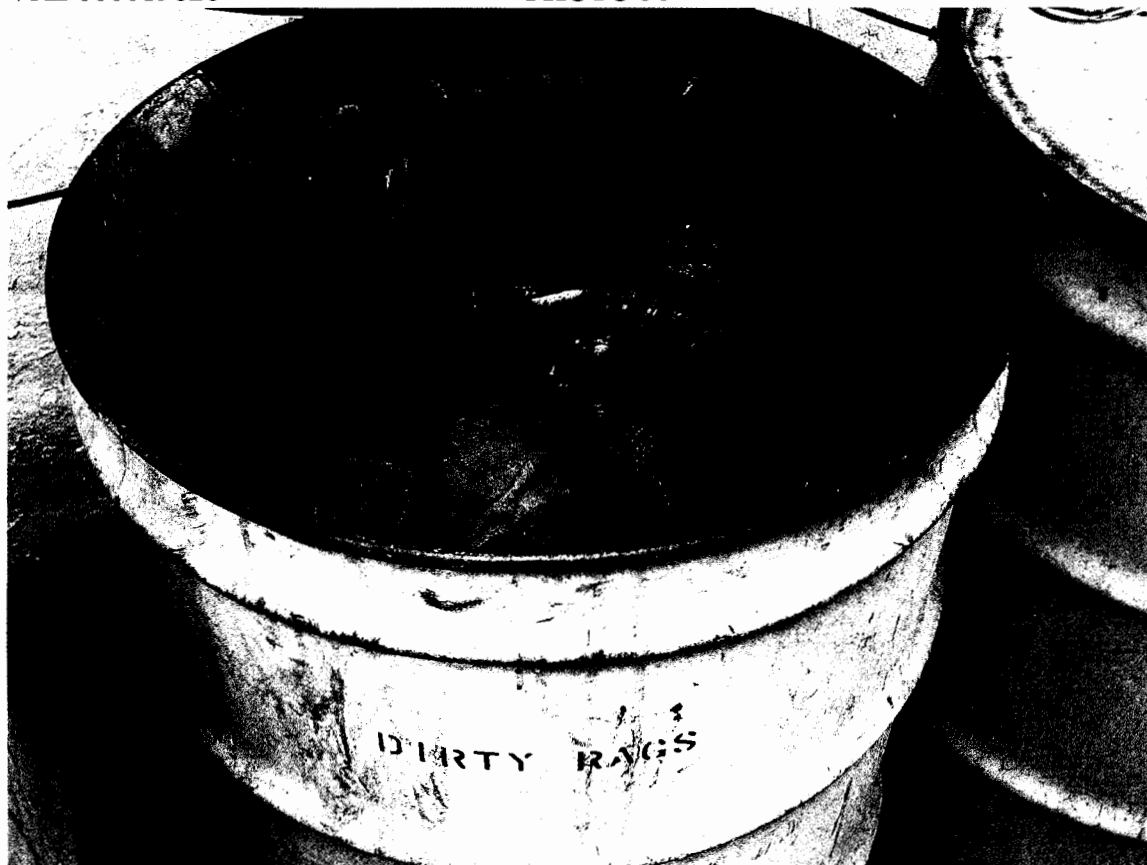
PHOTO 56

Outside of Maintenance Building

Part of 4 drums where dirty rags are collected and sprayed with water from compressor
Note insert at 1:00 near top of drum. This is where the water is sprayed from

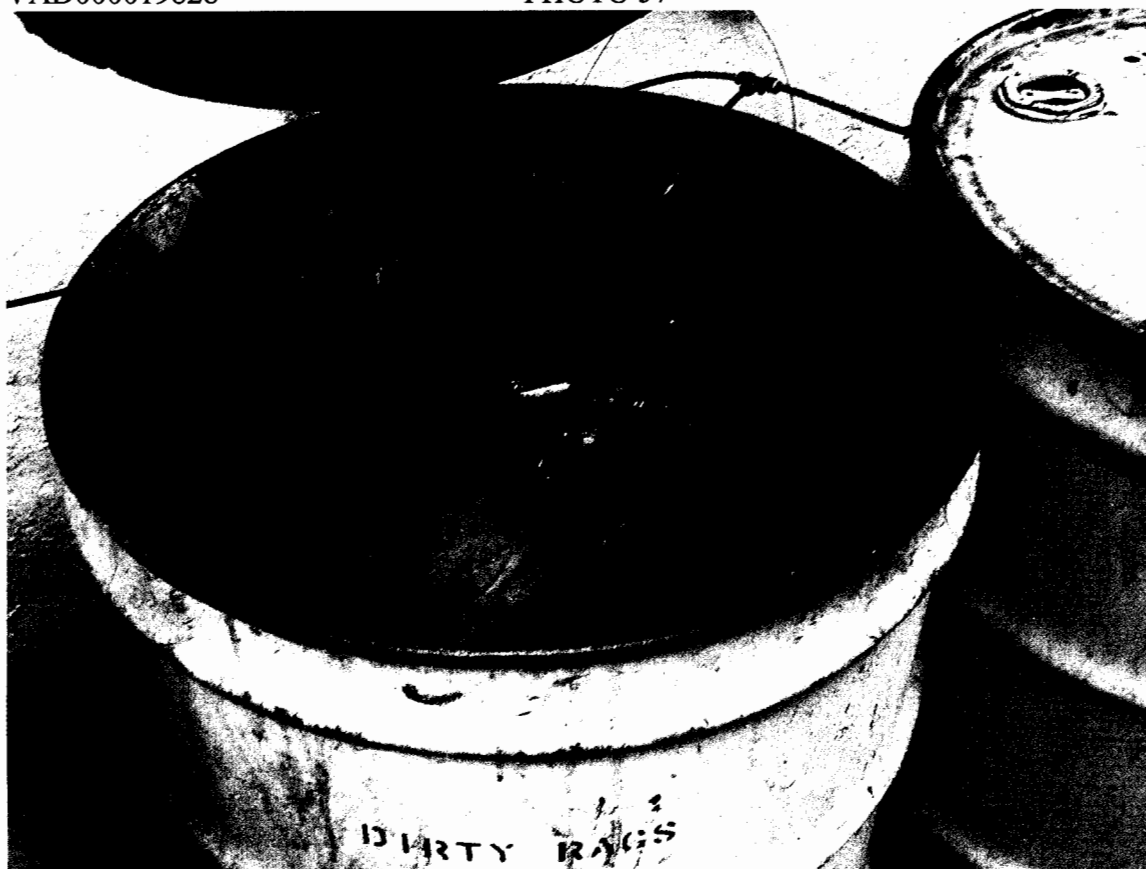
PHOTO 57

Same drum as from PHOTO 56

The water can be seen spraying from the insert

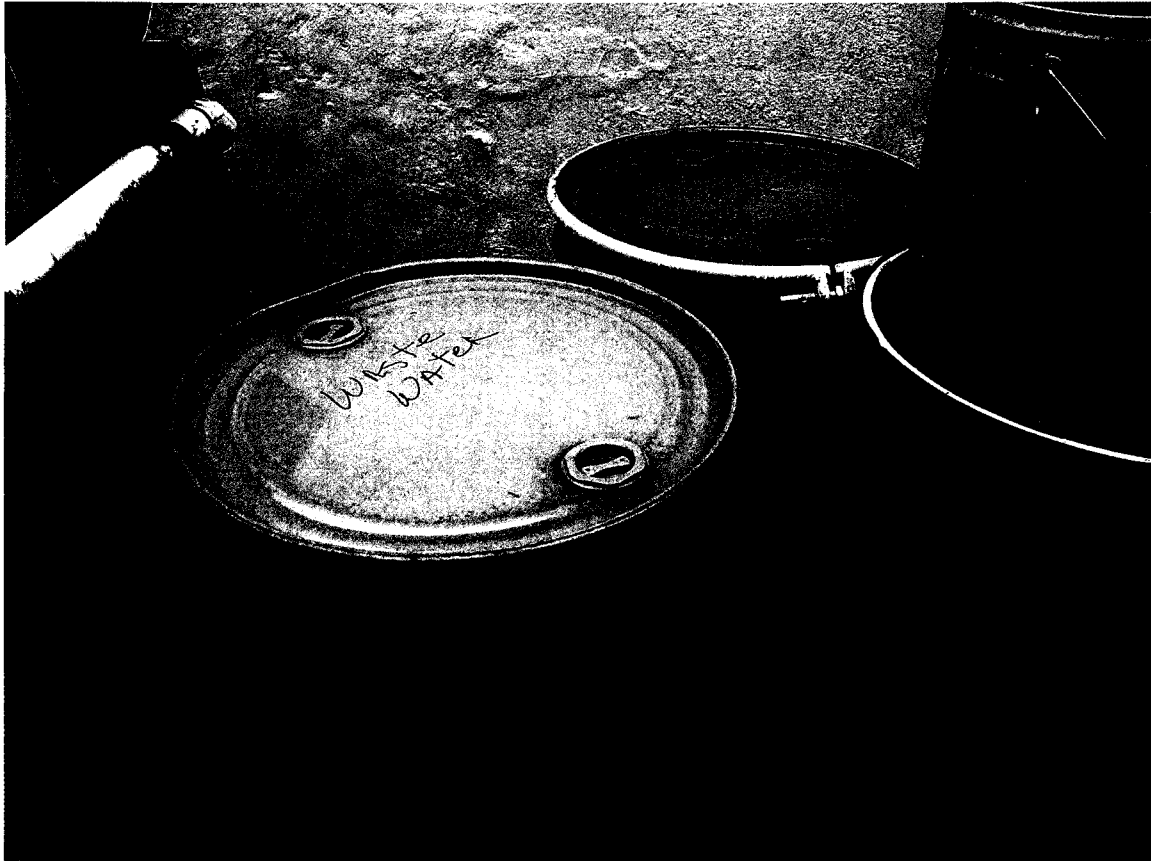
PHOTO 58

Outside of Maintenance Building

Two 55 gal containers labeled "Wastewater" One was labeled "04-04-05 test ok"
The other was approx. 20% full of dirty-looking liquid
